**COMMONWEALTH OF PUERTO RICO / OFFICE OF THE GOVERNOR
ENVIRONMENTAL QUALITY BOARD
EMERGENCY RESPONSE AND SUPERFUND PROGRAM**

**Re: Puerto Rico Containers (PRC) (a. k. a. Union Camp, International Paper Puerto Rico,
Puerto Rico Containers Company Limited, PRCC, ABC Containers)**
State Road 2, Km 15.2, Corujo Industrial Park, Hato Tejas, Bayamón

Included in this letter are the findings obtained during the Site Inspection of the PRC site. This investigation was performed by personnel from the PREQB Superfund PA/SI Division and included the review of all available information obtained from different sources (including the PREQB files), a target survey, various interviews, and a visual inspection performed at PRC on **March 17, 2005**. A sampling event was not performed during this investigation due to the conditions observed at the PRC site during the visual inspection performed on **March 17, 2005**. The site conditions observed will be described later in this Site Investigation (SI) Letter Report.

OFF / ON SITE RECONNAISSANCE PHOTO LOG REPORTING FORM

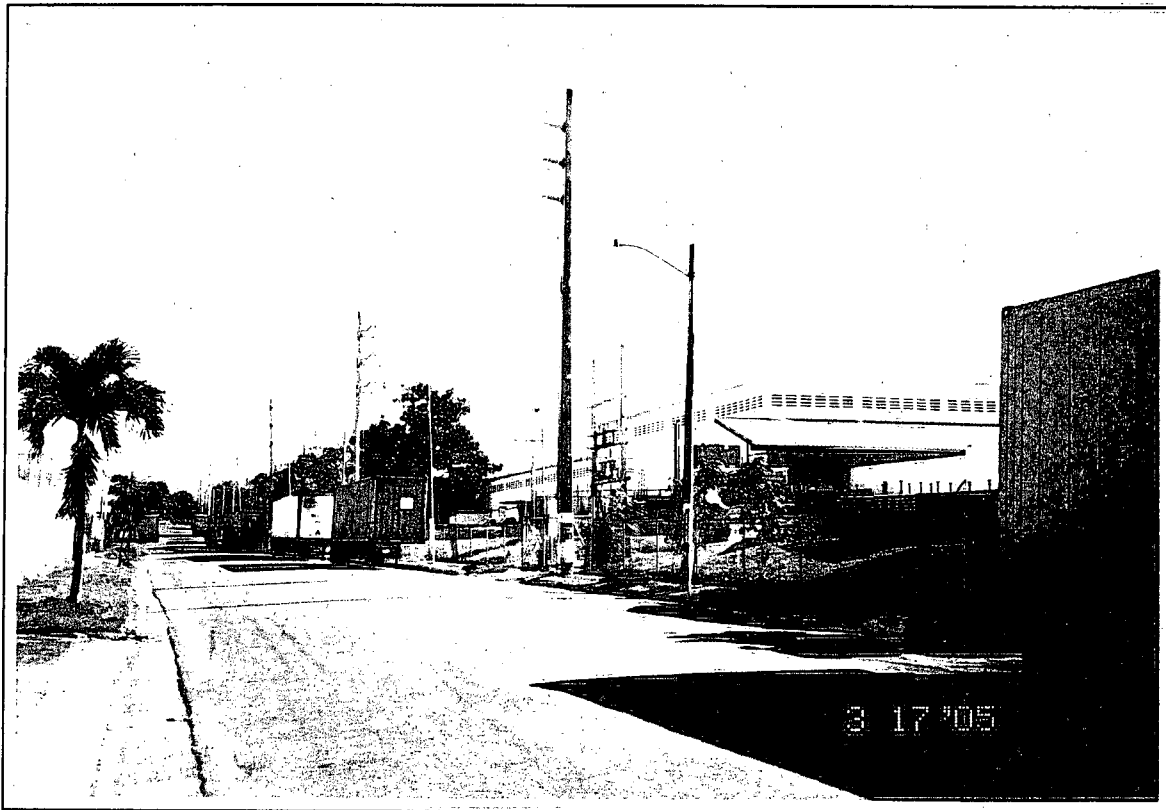
PHOTO 12

- 1515 hours** Left ANIXTER and drove north and along building #1. There is a large area covered with vegetation on the western corner of the site and an asphalted road that borders the western side of building #1 (Figure 12). This road reaches the north side of the property (Figure 2). No stressed vegetation was observed in the area described.
